# **Winstanley and York Road Estate Regeneration**

## **Arboricultural Assessment**

# **Arboricultural Development Statement**

## ***Winstanley & York Road Estate Regeneration Project, York Road Estate, York Gardens and part of Winstanley Estate***

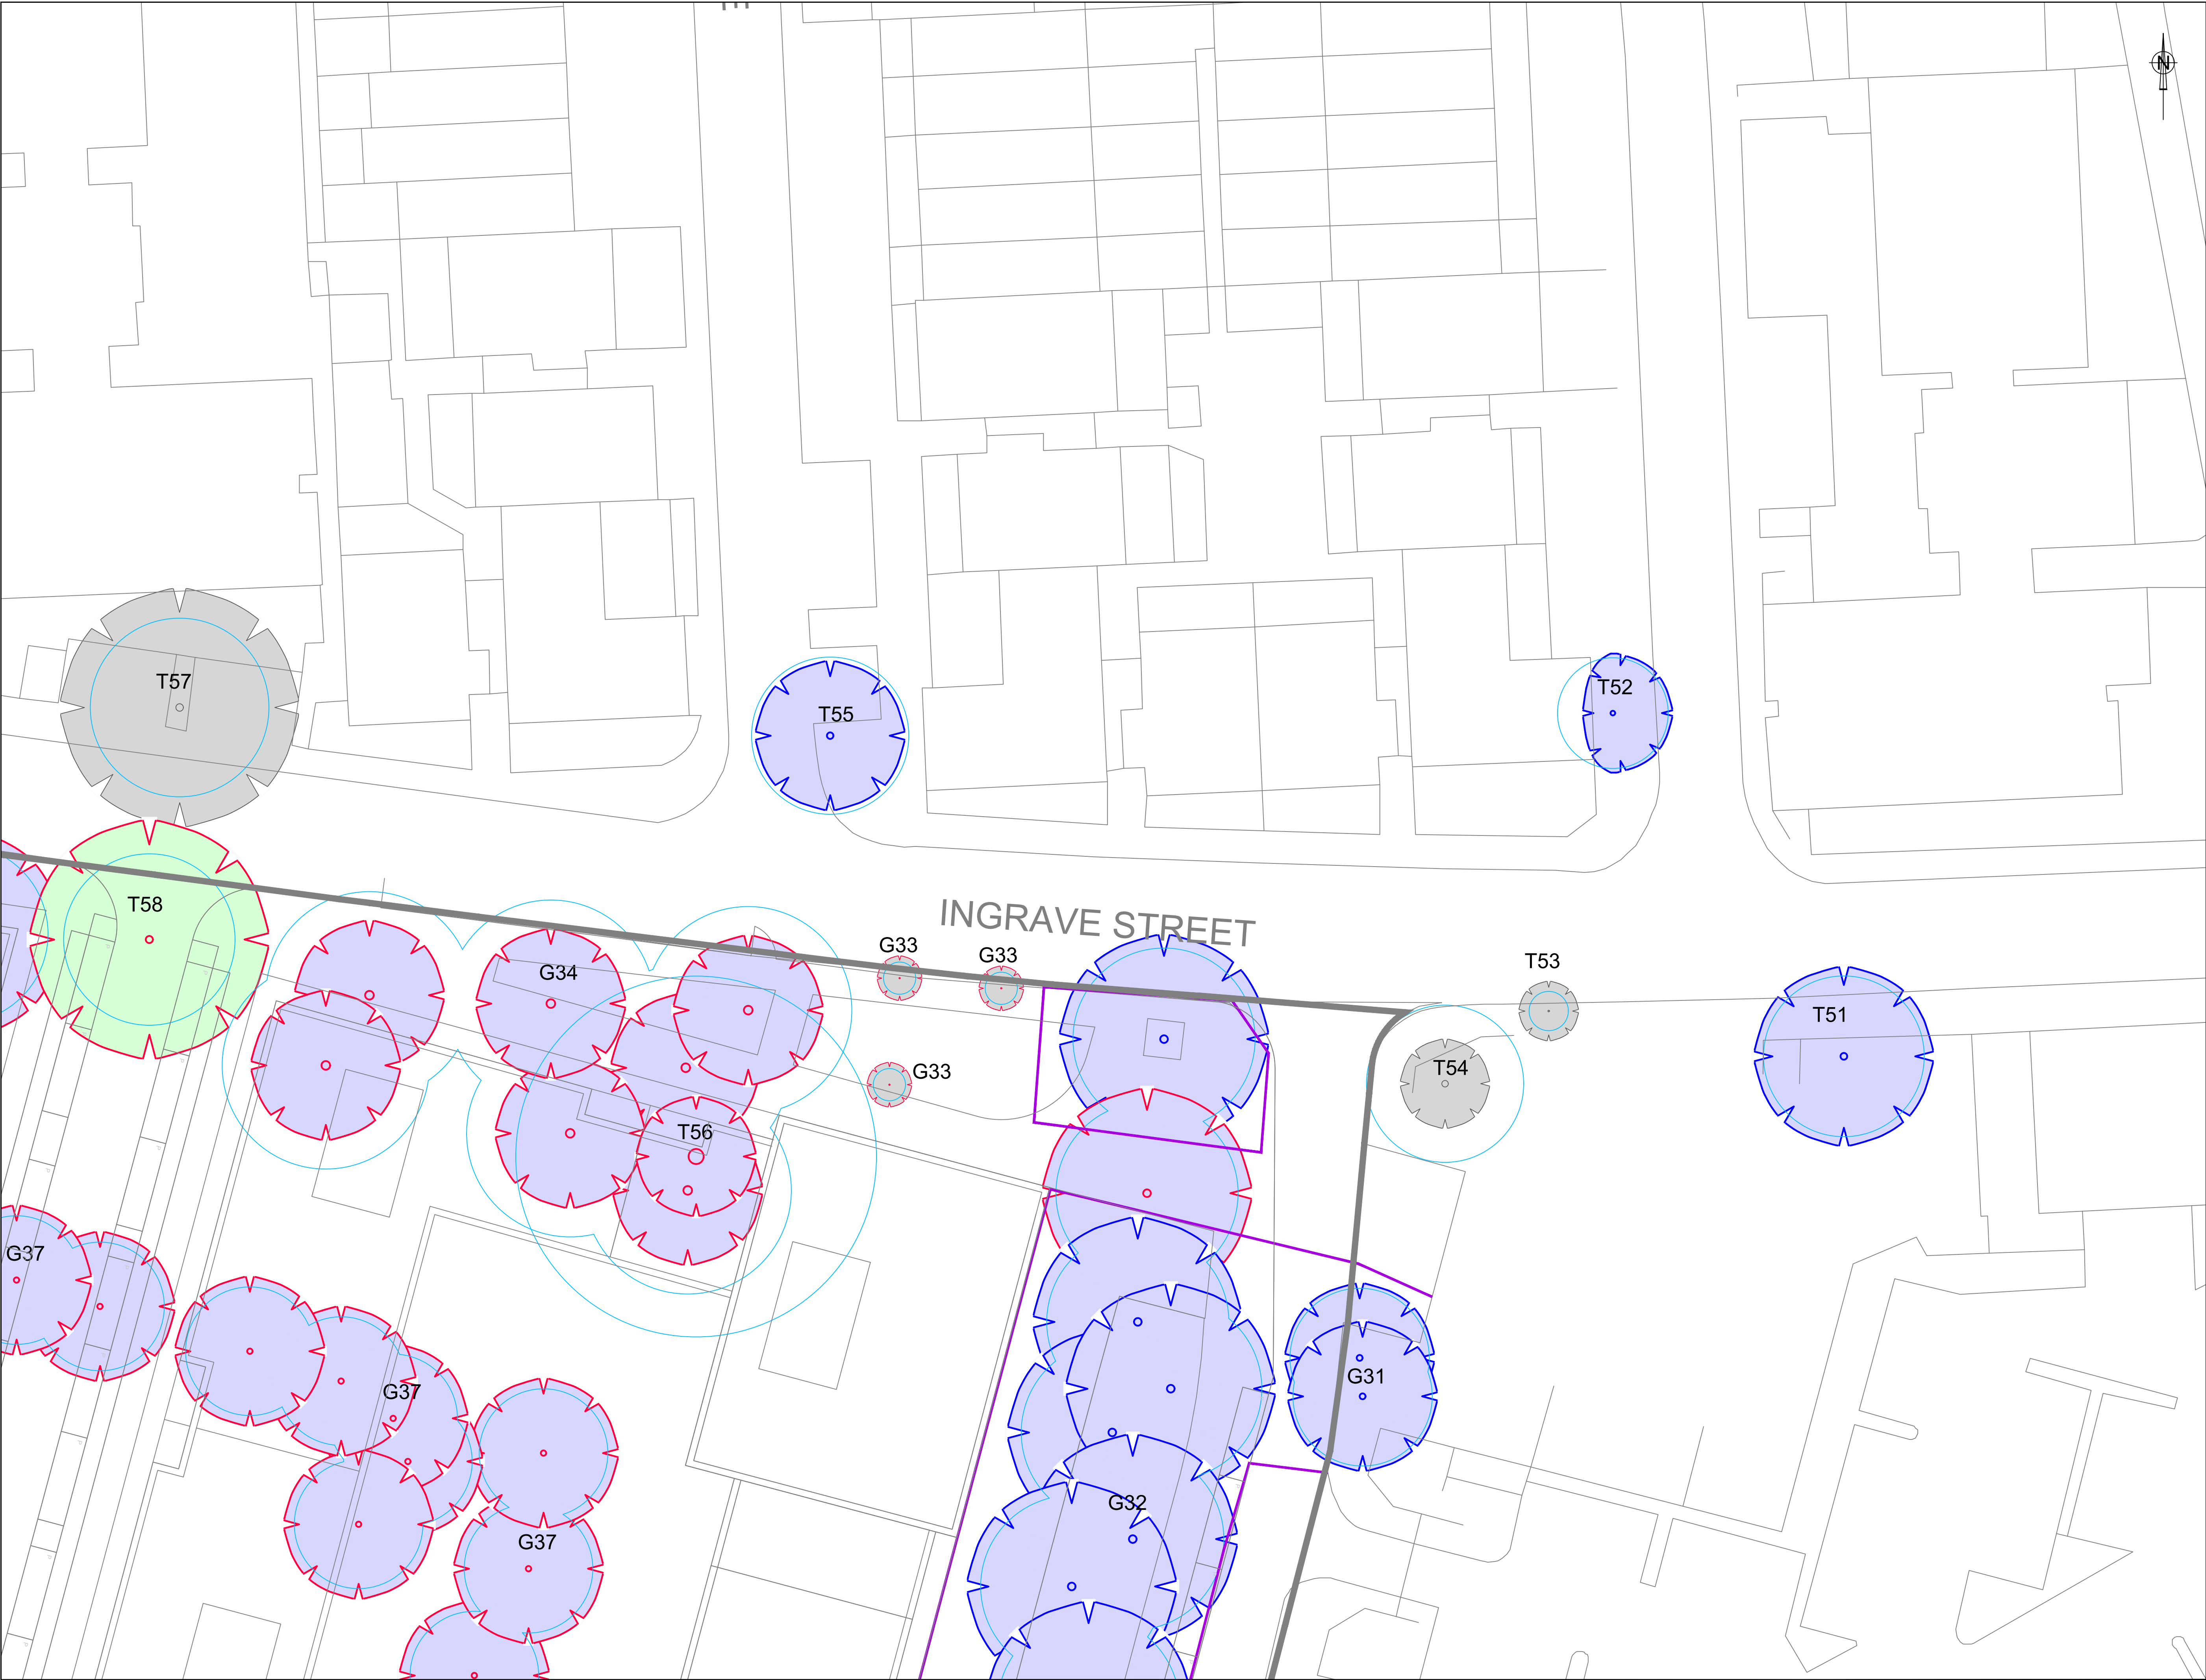
DATE	19/06/18
SCALE	1:200
PROJECT NUMBER : DRAWING NUMBER	
P2929.1 - 055 revB

Trees categorised in accordance with BS5837:2012 "Trees in relation to design, demolition and construction - Recommendations"
